| <b>Prüfbericht-Nr.:</b><br>Test report no.: | <b>CN23NZOY 001</b> | <b>Auftrags-Nr.:</b><br>Order no.: | 170347210 | Seite 1 von 8<br>Page 1 of 8 |
| <b>Prüfgegenstand:</b><br>Test item: | Foldable solar balcony structure | | | |
| <b>Bezeichnung / Typ-Nr.:</b><br>Identification / Type no.: | WH-T-Y-45 | | | |
| <b>Auftrags-Inhalt:</b><br>Order content: | Wind load resistance performance test for Foldable solar balcony structure | | | |

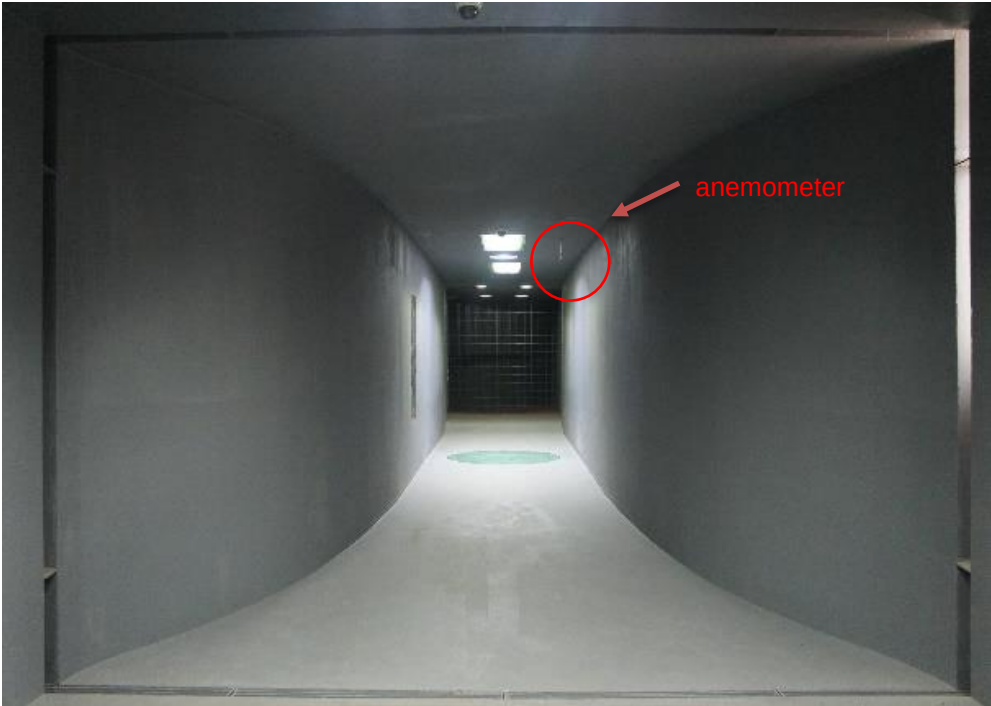
| 8.1 | <b>Test background and apparatus</b><br><br>This test was carried out in the small test section (1.8m×2.0m) of CGB-1 wind tunnel laboratory. Wind pressure and wind velocity can be read via anemometer installed in the test section. The anemometer is pitot tube, located beneath 1.8m and 1.5m ahead of the centre of test turntable. Pitot tube is connected with fan control system by pressure sensors. The interior of wind tunnel is shown in Figure 1. | | |
| | Figure 1. Wind tunnel | | |

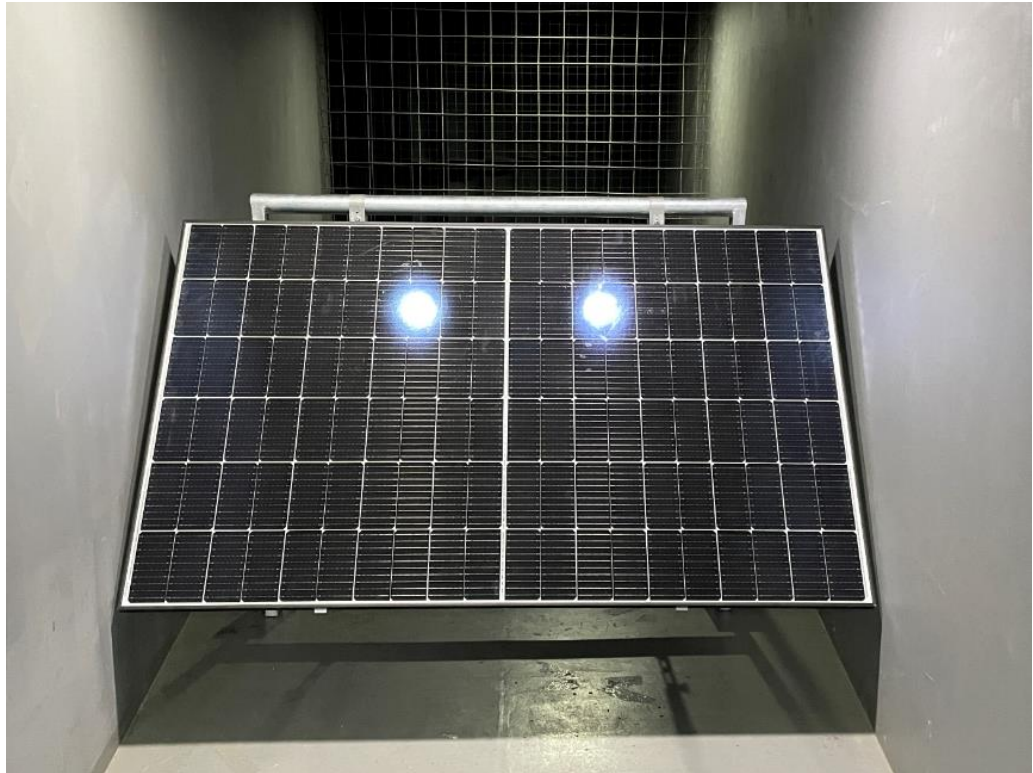
Figure 2. PV module facing wind (0°)

| 9.1 | PV module facing wind (0°) | | | |
| | Facing the wind (0°) | 0 | / | All parts of the sample are firmly installed |
| | | 15 m/s | 10 min | There is no obvious vibration of the PV module detected, and no connection or component damage occurred. |
| | | 25 m/s | 10 min | There is no obvious vibration of the PV module detected, and no connection or component damage occurred. |
| | | 34 m/s | 10 min | There is no obvious vibration of the PV module detected, and no connection or component damage occurred. |
| | | Turn off the blower | / | There is no visual deformation on the sample, and no loosening or destruction of component after testing. |

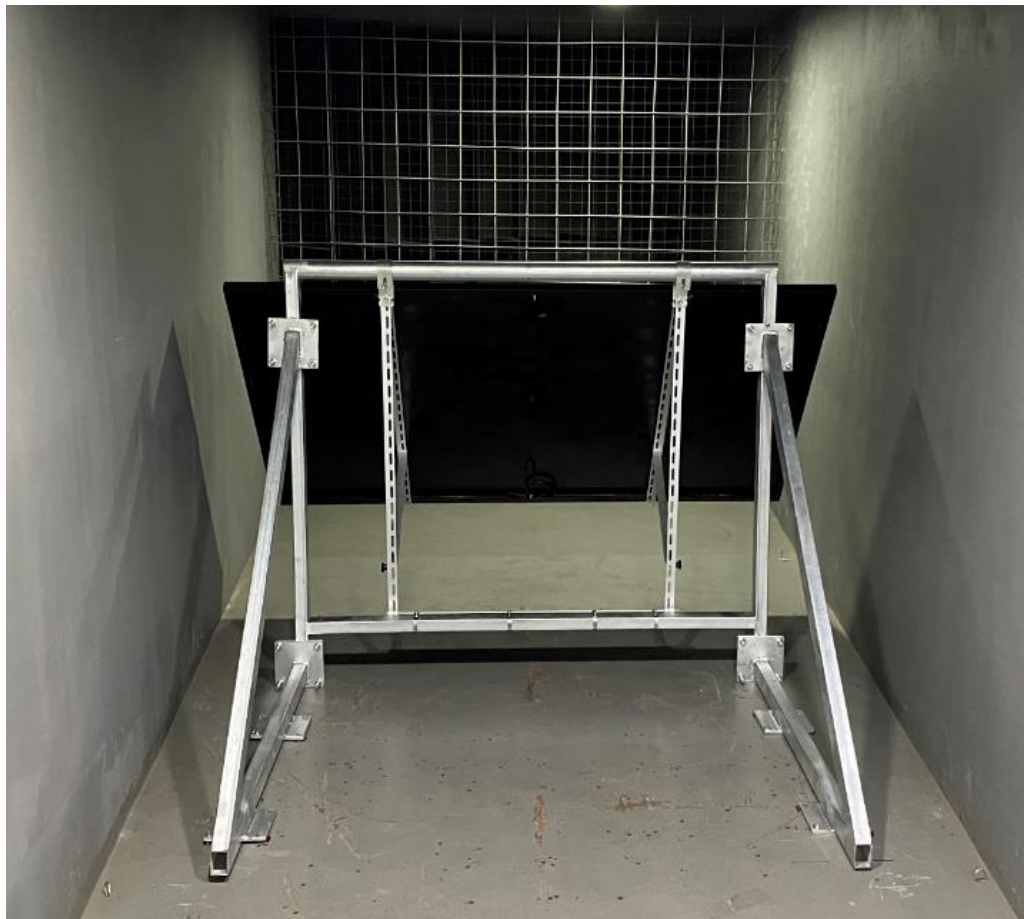
Figure 3. PV module back side facing wind (180°)

| 9.2 | PV module back side facing wind (180°) | | | |
| | Back side facing the wind (180°) | 0 | / | All parts of the sample are firmly installed |
| | | 15 m/s | 10 min | There is no obvious vibration of the PV module detected, and no connection or component damage occurred. |
| | | 25 m/s | 10 min | There is no obvious vibration of the PV module detected, and no connection or component damage occurred. |
| | | 34 m/s | 10 min | There is no obvious vibration of the PV module detected, and no connection or component damage occurred. |
| | | Turn off the blower | / | There is no visual deformation on the sample, and no loosening or destruction of component after testing. |

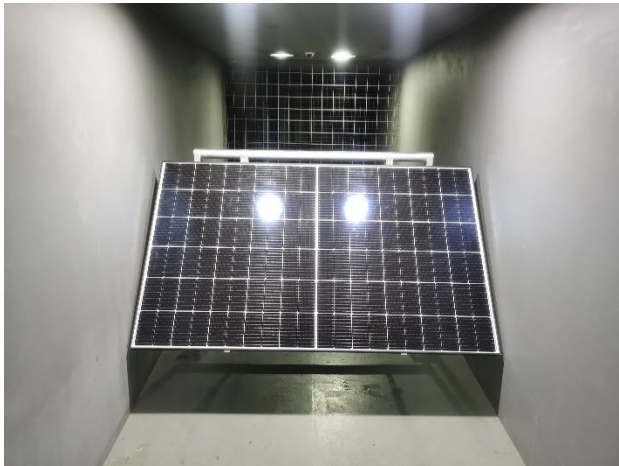
| 10.1 | PV module facing wind (0°) | | |

| | Before test | After test | |

There is no visual deformation on the sample, and no loosening or destruction of component after testing when the wind velocity reached 34 m/s (122.4 km/h) under two different wind direction test condition.

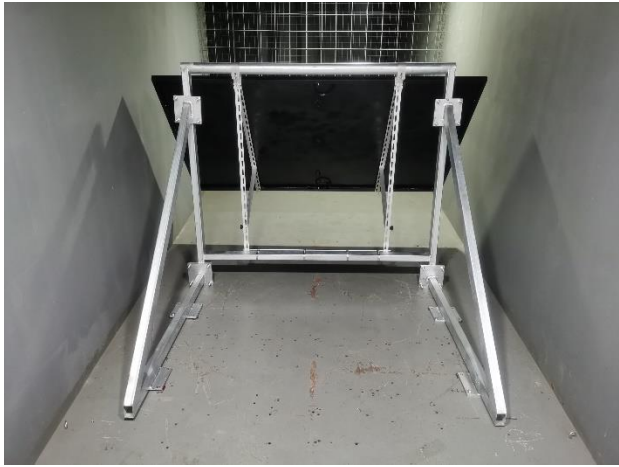
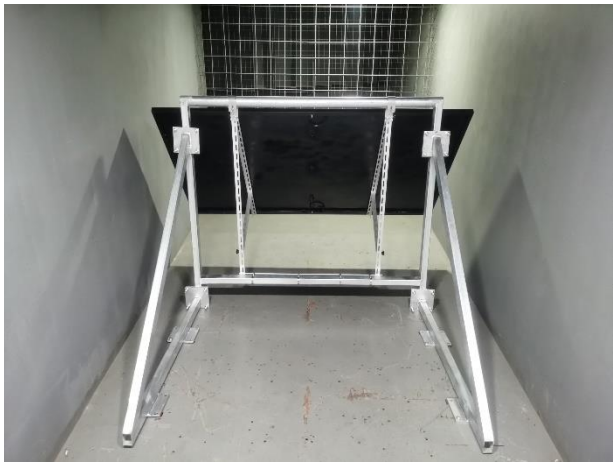
| 10.2 | PV module back side facing wind (180°) | | |

| | Before test | After test | |
